Existing Conditions Analysis

ROUTES 303/304 SAFETY AND SUSTAINABILITY STUDY, CLARKSTOWN, NY

Town of Clarkstown
Rockland County Department of Planning

Town of Clarkstown
Rockland County Department of Planning
October 2024

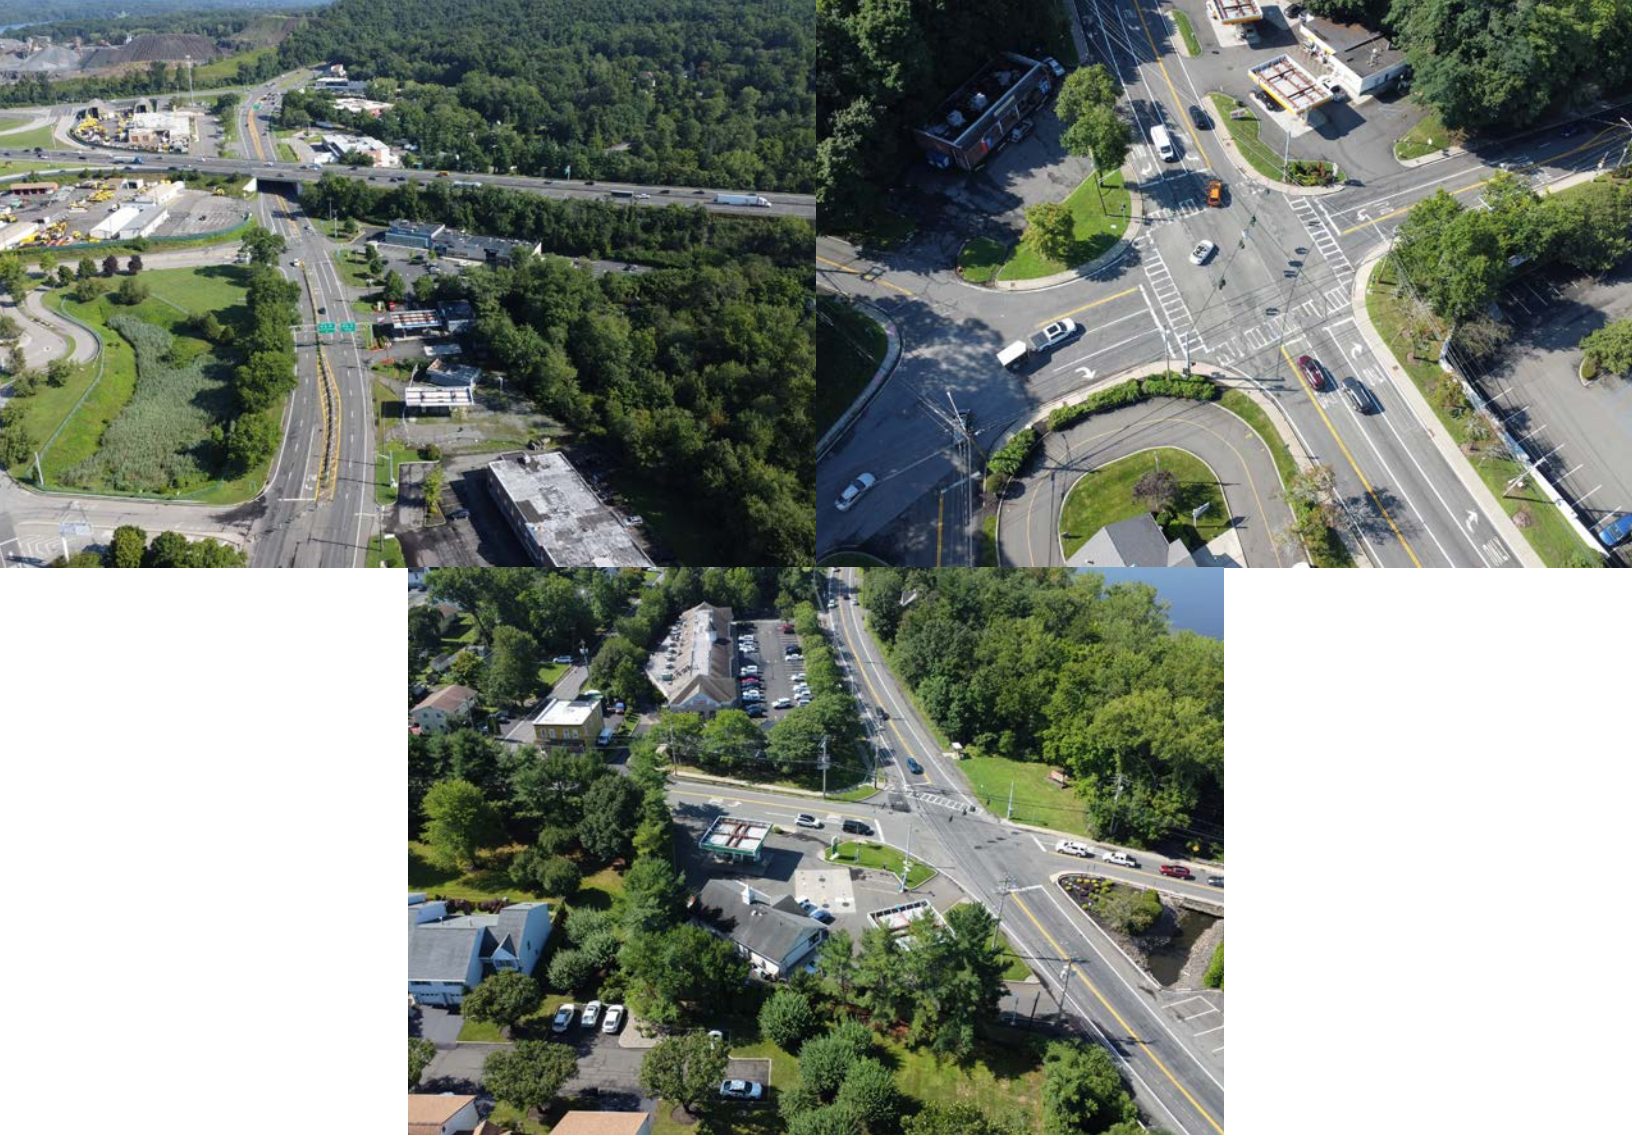
Figure 2: Clockwise from top-left: Route 303 at Palisades Center Mall looking north, at Lake Road (Valley Cottage) looking south, and at Lake Road (Congers) looking south

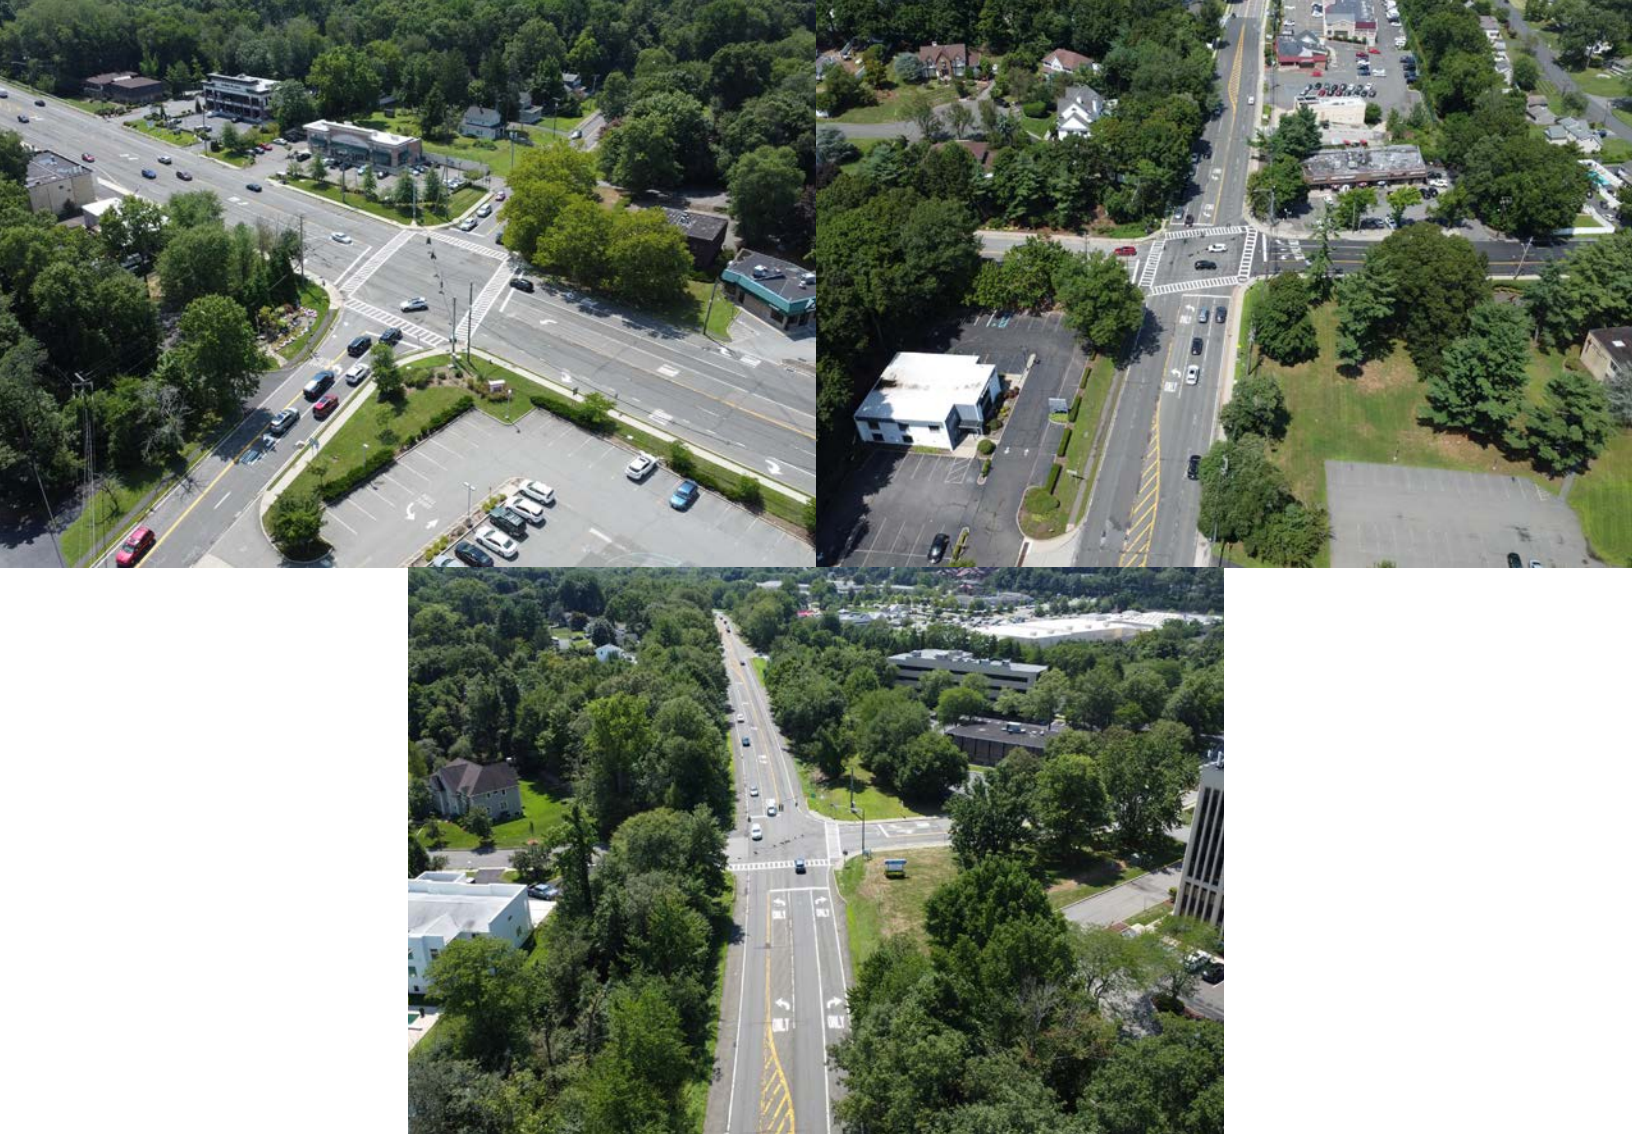
Figure 3: Clockwise from top-left: Route 304 at Bardonia Road looking west, at Germonds Road looking north, and at Squadron Boulevard looking south

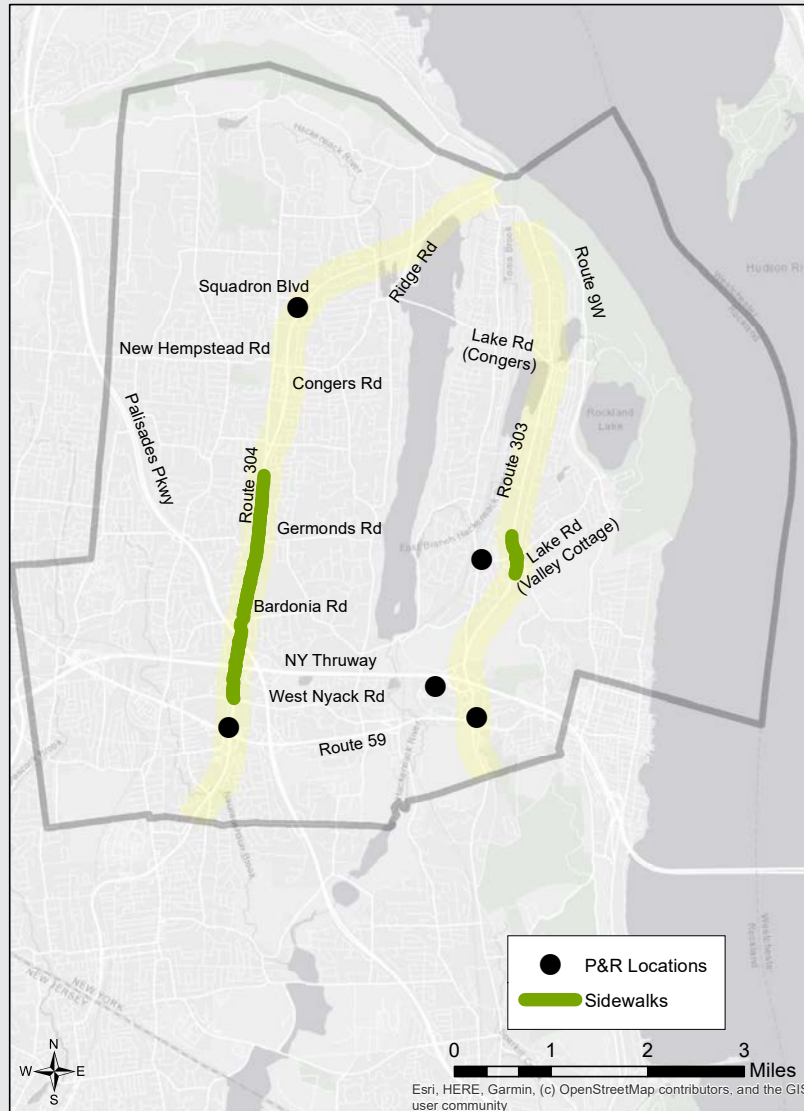
Figure 10: Sidewalks and Park-and-Ride Locations

can also be seen in Figure 10. Sidewalks are found on Route 303 in Valley Cottage, in the vicinity of Lake Road. On Route 304, sidewalks are found from West Nyack Road (where the freeway section to the south transitions to be a signalized arterial) to Virginia Street, approximately 1,000' south of South Main Street in New City. Accommodation for pedestrians is discussed further in the next Chapter.

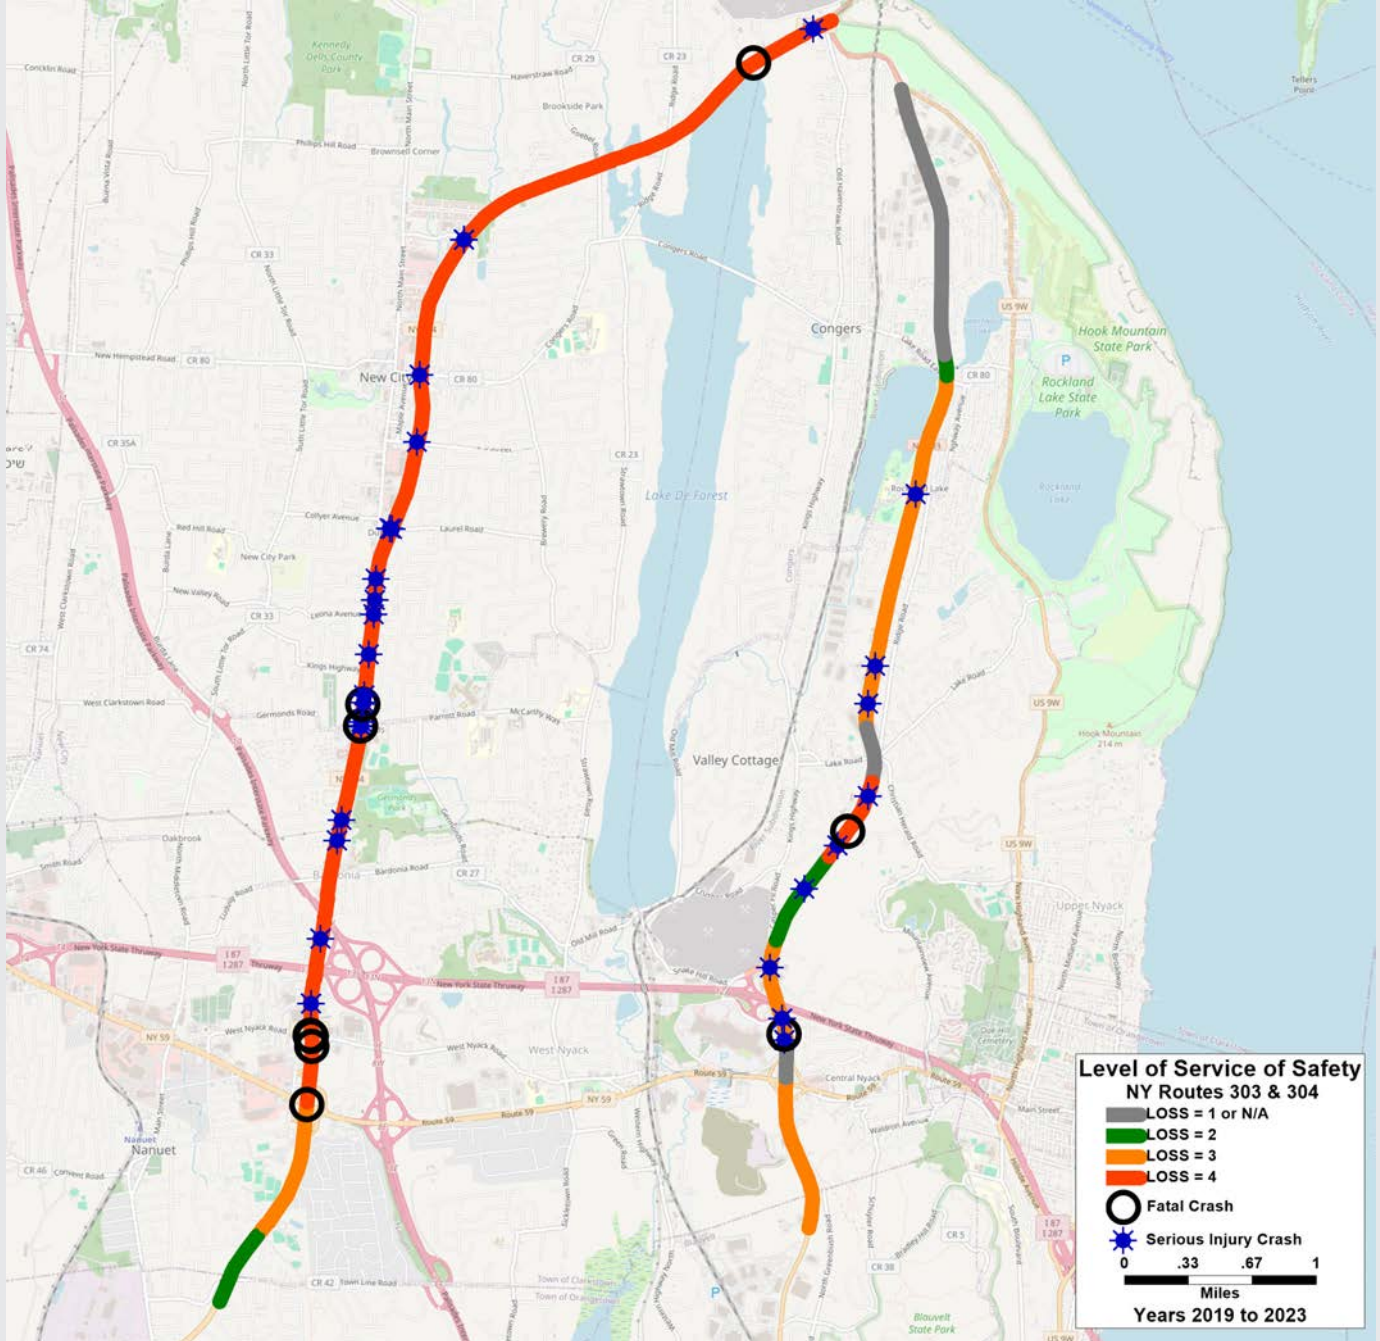
Figure 19: Level of Service for Safety (LOSS) Values from NYS’s CLEAR System

Level of Service of Safety (LOSS) is the ranking of sites according to their observed and expected crash frequency for the entire population, where the degree of deviation is then labeled into four classes of level of service.

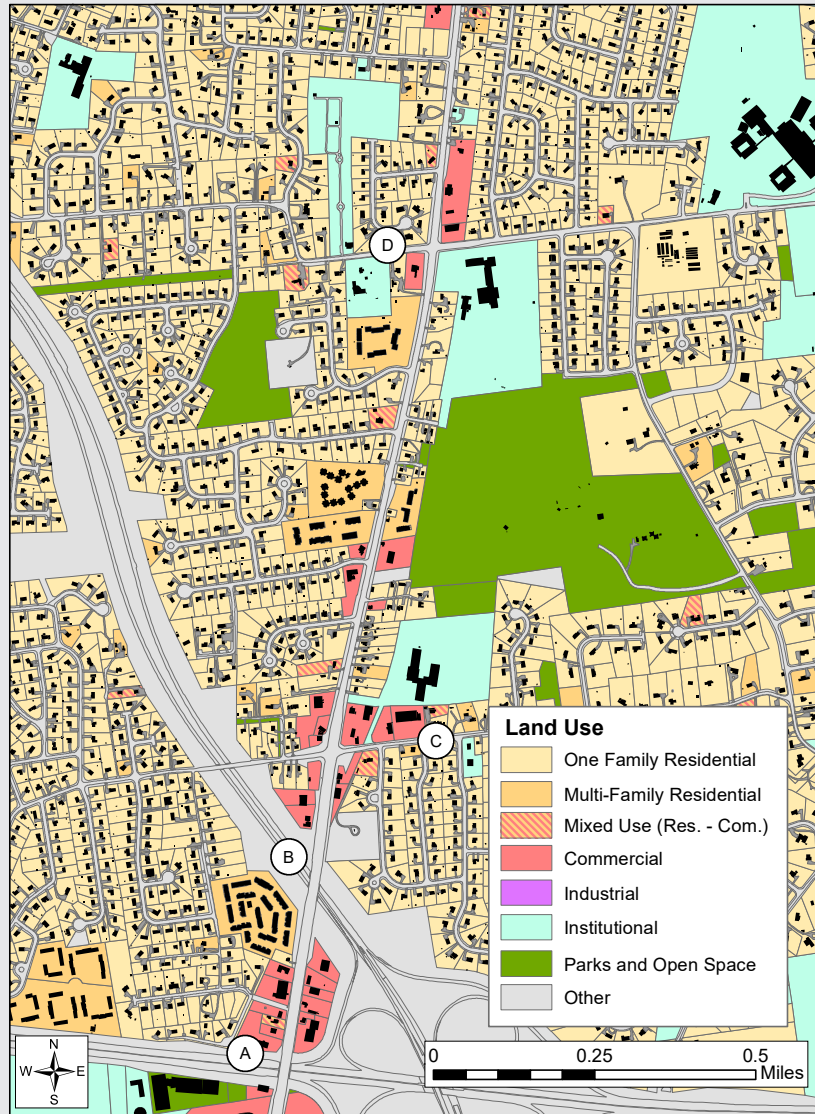
- A: NY Thruway
- B: Palisades Pkwy
- C: Bardonia Rd
- D: Germonds Rd

Figure 30: Land use on Route 304 between NY Thruway and Germonds Rd

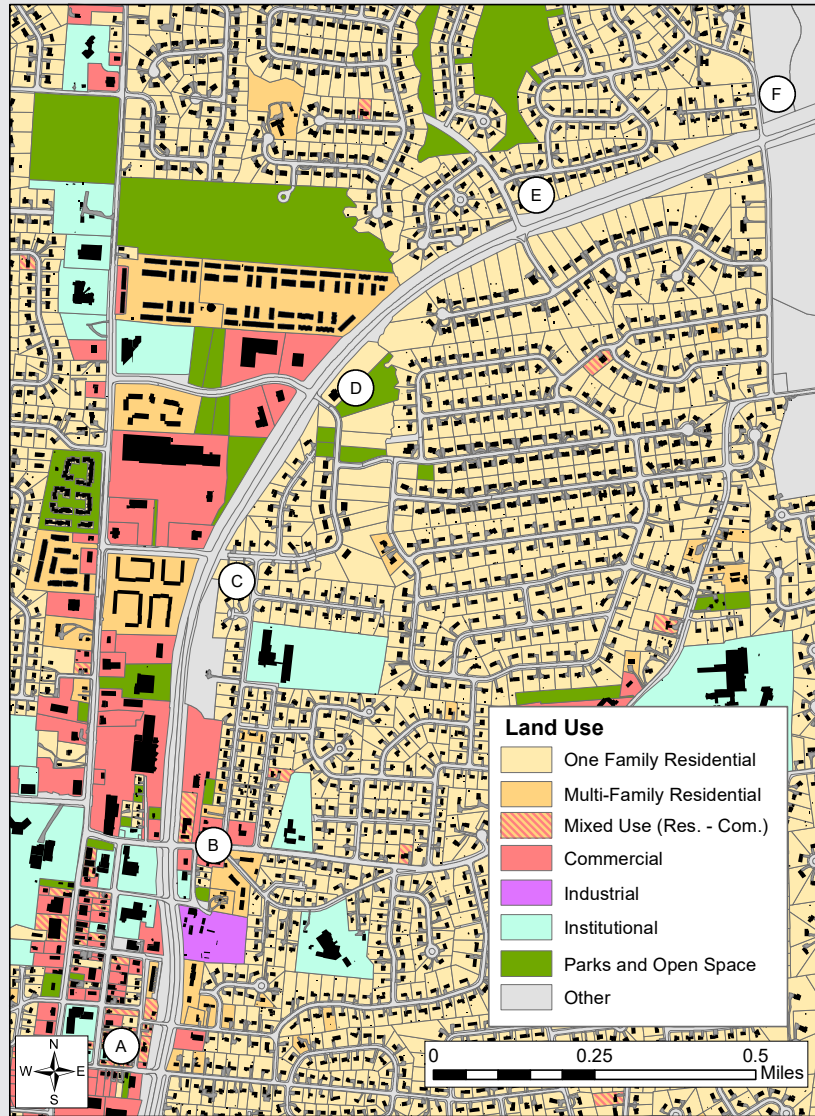
- A: 3rd St
- B: Congers Rd
- C: Calvary Dr
- D: Squadron Blvd
- E: Phillips Hill Rd
- F: Goebel Rd

Figure 32: Land use on Route 304 between 3rd St and Goebel Rd

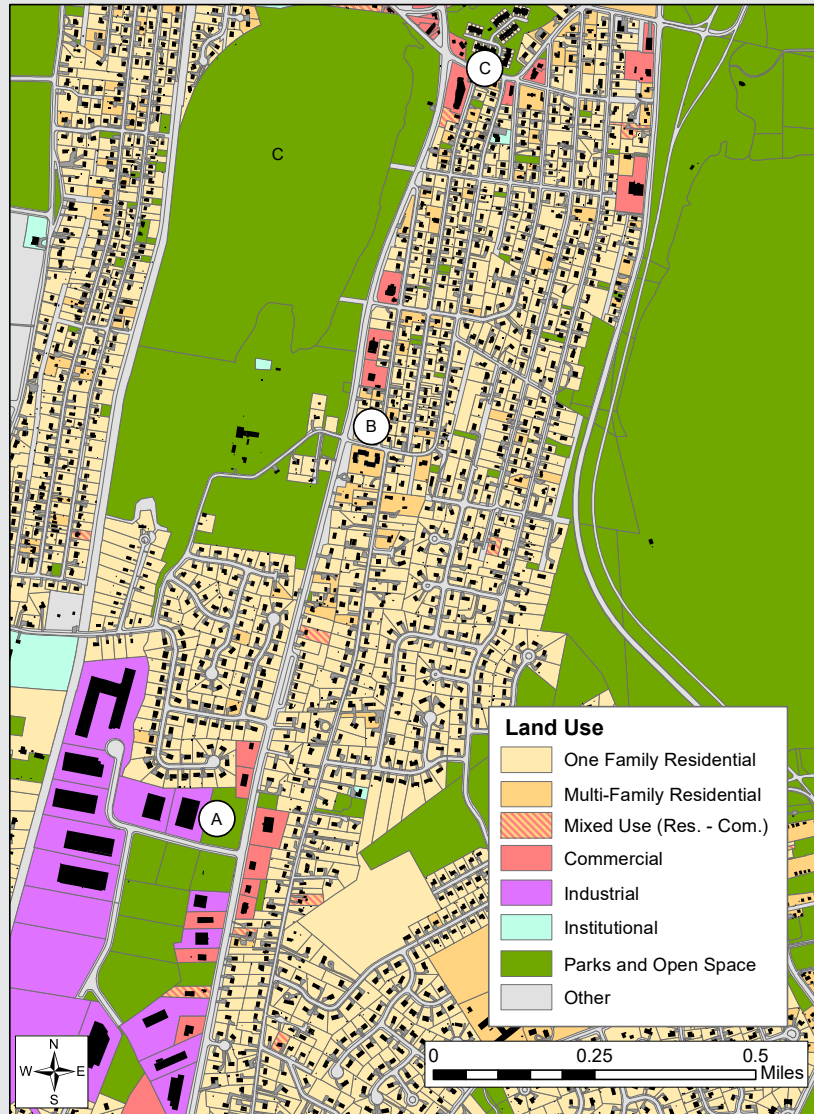
- A: Executive Blvd
- B: Gilchrest Rd
- C: Lake Rd (Congers)

Figure 36: Land use on Route 303 between Executive Blvd and Lake Road (Congers)

To the north of Lake Road (Valley Cottage) are larger commercial and industrial properties (including the Clarkstown Executive Park), along with single-family homes on the east side of the corridor (Figure 35). After Executive Drive, adjacent uses are mainly single-family residential (with some small-scale multi-family and commercial properties), and Congers Lake Memorial Park on the west side of the corridor (Figure 36).
